CAPPING AND DREDGING CONSTRUCTION COMPLETION REPORT ONONDAGA LAKE

Honeywell

PARSONS

September 2017

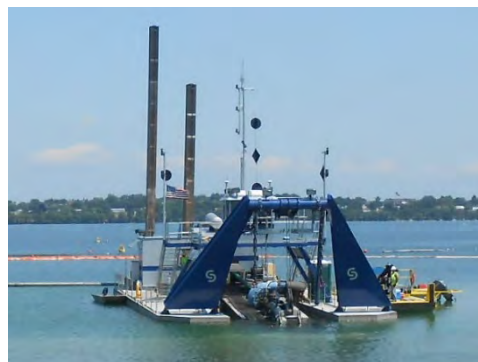
16-inch Dredge (Marlin Class)

- Dredging Supply Company, Inc. (DSC), Marlin 7650D dredge with a 16-inch-diameter discharge line and a 30-foot spud carriage

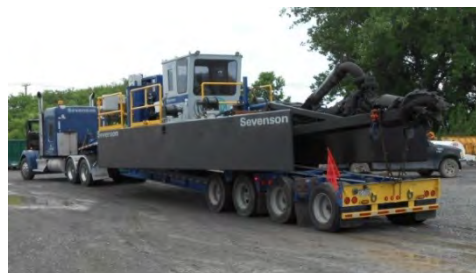
8-inch Dredge (Moray Class)

- DSC Moray 2000D swinging ladder dredge with an 8-inch-diameter discharge line

The 16-inch dredge was used as the primary production dredge, and focused on areas with thick dredge cuts for maximum operational efficiency. The 16-inch dredge operated for approximately 72% of the total dredge hours. The 14-inch dredge was used as a production dredge when the 16-inch dredge was unavailable, when operational needs required frequent transitioning of dredging operations between different portions of the lake, or to make thin cleanup passes in previously dredged areas. The 14-inch dredge operated for the remaining 28% of the total dredge hours. The 8-inch dredge was available as a specialty dredge for areas of shallow water or for thin dredge cuts; however, sufficient water draft was available

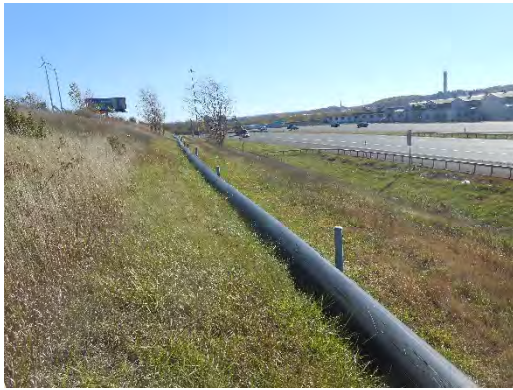
Dredge Slurry Pipeline

The alignment of the pipeline generally followed the *Onondaga Lake Sediment Management Final Design* (Parsons 2011a), with minor deviations to accommodate field conditions encountered during the installation. The pipeline route generally followed the I-690 corridor to its intersection with Ninemile Creek, after which it followed the Creek and State Fair property to the Honeywell Wastebeds 12-15 site (Figure 1-1). The slurry pipeline comprised double-walled high-density polyethylene (HDPE) pipe. The inner slurry conveyance pipe had an outer diameter of 16 inches and inner diameter of 12.3 inches, and the outer secondary containment pipe had an outer diameter of 22 inches. The double-walled pipe was located primarily aboveground except for limited locations where road/rail crossings required burial, and in a limited area of the State Fair black lot where State Fair use of the property dictated burial. Four electrical-powered, 600-horsepower booster pumps were spatially distributed along the pipeline to provide sufficient pressure head to convey the slurry to the dewatering area.

To safeguard against potential leaks, several leak detection features were built into the system. The interstitial space between two walls of the double-walled pipe was monitored for pressure fluctuations. In addition, liquid leak detection points were constructed at low points along the pipeline alignment, where any potential liquids leaking from the inner pipeline would migrate. Booster pumps were situated in lined, walled enclosures, which were designed to contain a volume of slurry corresponding to the volume contained in the pipeline from the booster pump to the next “high” spot in the pipeline. The enclosure included a sump, which had level sensors in the event of a pipeline or pump leak. These systems featured alarm functions, which tied into the overall control system that monitored all equipment, from the dredge to the WTP. Operators monitoring the system had the capability to completely shut the system down, if needed.

During the 3-year period in which the dredging occurred, an inspector walked the entire length of the pipeline daily, monitoring for any potential changes or issues that would need to be addressed. In addition, pipe wall thickness was monitored on a routine basis. Based on these readings, several steps were taken over the course of the project to extend the life of the pipeline and prevent potential leaks. These steps included rotation of the pipeline, modification of the route to reduce the number of fittings (e.g., elbows), and full replacement of pipe sections and fittings.

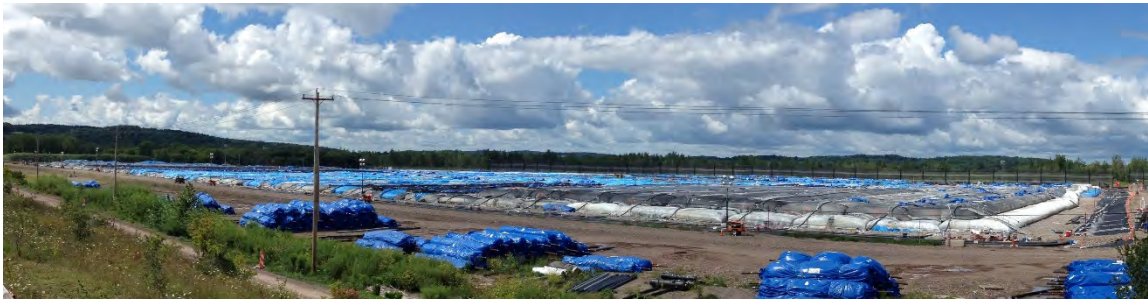
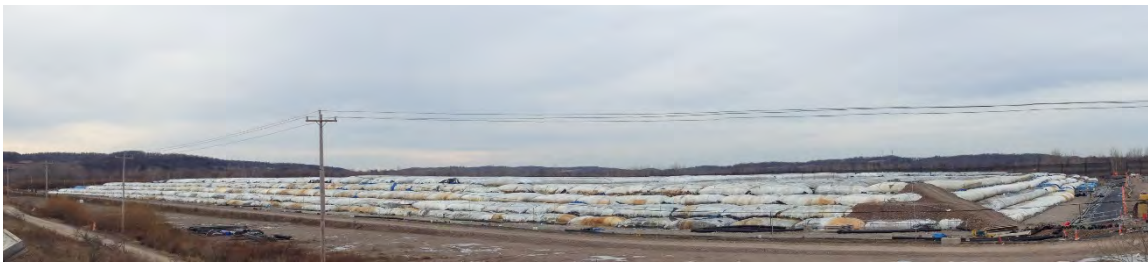
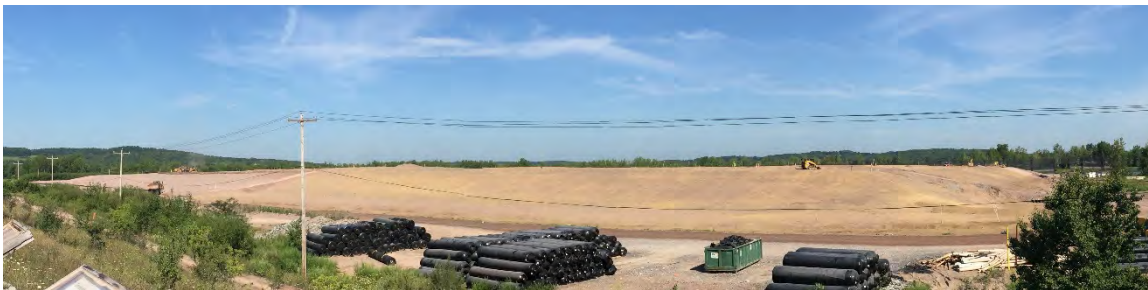
weep through the tube mesh openings, while dewatering sediments remained within the tube. A total of 979 tubes of up to 300 feet in length were filled during the project. Geotextile tubes were stacked into five layers. Deployment and filling of the tubes were completed in consultation with design engineers, and considered monitored settlement of the SCA, water flow, rate of sediment dewatering, and other considerations.

SCA During Dredging

SCA Post-Dredging

SCA During Cover Placement

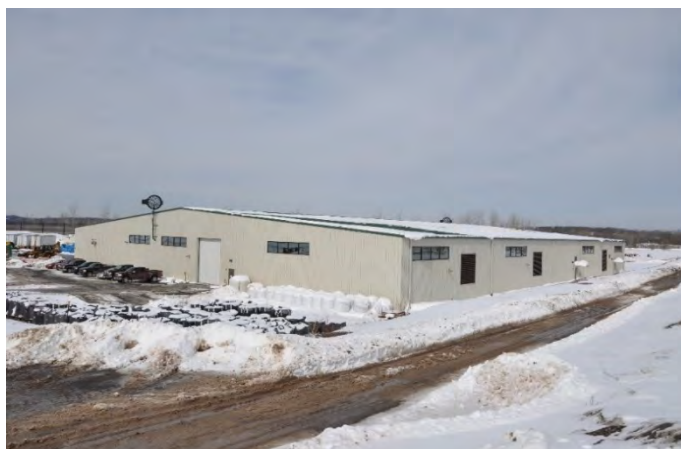
SCA Water Treatment Plant

Process water from the slurry thickeners, decant water from the geotextile tubes, and stormwater collected in the SCA and slurry processing areas were directed to the on-site WTP. The WTP was constructed near the southeast corner of the SCA prior to the initiation of dredging.

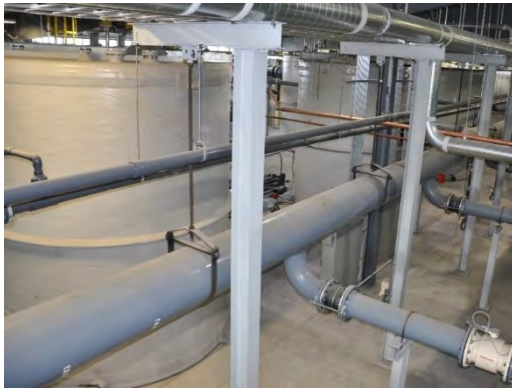
pH Adjustment Tanks

metals from the water. Aluminum sulfate (alum) was also added at each pH adjustment train. The pH-adjusted water was subsequently dosed with polymer and subjected to flash mixing.

Following pH adjustment, the water was sent to an inclined plate clarifier (IPC) system; this system consisted of seven IPCs configured in parallel. Any IPC system could be isolated to allow for servicing or when the flow through the WTP was reduced. A flocculation tank was located upstream of each IPC for the agglomeration of solid particles. Suspended solids settled and accumulated in the base of each IPC vessel. This resulting sludge was transferred to a holding tank and subsequently pumped back to the SCA for disposal of the solids.

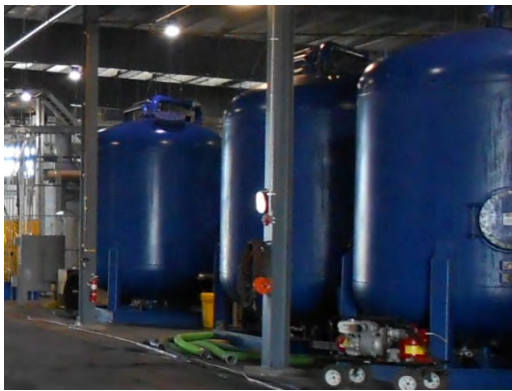
LGAC Vessels

was isolated and the media was replaced. Individual LGAC beds were periodically backwashed (using WTP-treated effluent water) and accumulated solids were transferred to the backwash pumping station.

LGAC effluent was discharged to the effluent monitoring tanks for final pH adjustment, as necessary. The treated effluent was typically pumped from there to the Metro facility for supplemental treatment and ultimate discharge to Onondaga Lake. Flow from the SCA WTP to Metro was temporarily halted during significant precipitation events; for the 2014 dredging season, a limited amount of water was discharged directly from the WTP to Onondaga Lake during such events, in accordance with a waiver issued by NYSDEC.

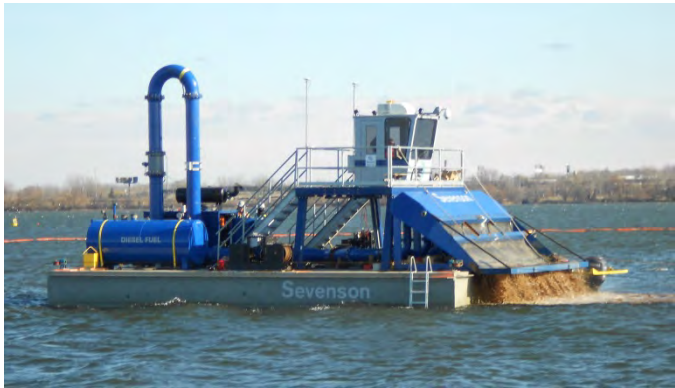
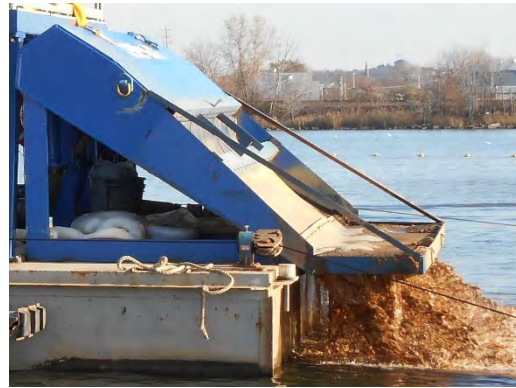
Hydraulic Spreader Barge

A custom hydraulic spreader barge was used for the hydraulic placement of cap material within the lake. The hydraulic spreader barge placed sand-sized materials, including the chemical isolation layers (sand-siderite and sand-GAC) and sand-only layers (un-amended chemical isolation layers, habitat layers, and thin-layer caps). A limited amount of fine gravel was also hydraulically placed in RA-A in December 2014.

Once the slurry reached the hydraulic spreader barge, the cap material was discharged off a 22-foot-wide steel spreader plate positioned at the bow of the hydraulic spreader barge and located approximately 3 feet above the water surface. To place a cap layer at the appropriate location, the hydraulic spreader barge traversed pre-designated capping lanes that were uploaded to the RTK-GPS controls on the hydraulic spreader barge.

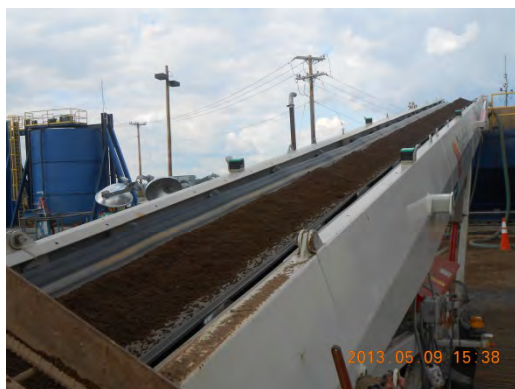
Sand Conveyor

To deliver sand to the hydraulic spreader barge, the contractor generated a slurry of sand and water and pumped the sand-water slurry to the hydraulic spreader barge. Sand was imported to the lakeshore area from multiple quarries (see Section 5.1.3) and stockpiled near equipment located on shore. Sand was loaded into a feed hopper using a PC350LC excavator, continuously weighed using a gravimetric weigh belt feeder with a reported accuracy of ± 2 to 5%, and transported by conveyor from the feed hopper to a slurry mix tank. The typical sand feed rate was 250 to 300 tons per hour. Lake water was pumped into the slurry mix tank, typically at a rate from 5,000 to 6,000 gallons per minute, from a makeup water

pump positioned on a modular barge located offshore adjacent to the land-based cap mixing operation. A booster pump then transported the sand and water slurry from the slurry mix tank through a 16-inch, HDPE slurry transport line to the hydraulic spreader barge.

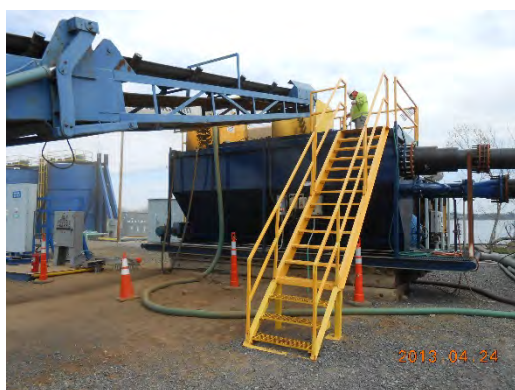
Siderite Conveyor

For the chemical isolation layers, siderite or GAC was added to the sand-water slurry at the required dose as appropriate. For sand-siderite capping, siderite was added to the slurry mix tank by using a separate feed hopper and conveyor system positioned parallel to the sand hopper and conveyor, also with a reported accuracy of ± 2 to 5%. Siderite feed rates were

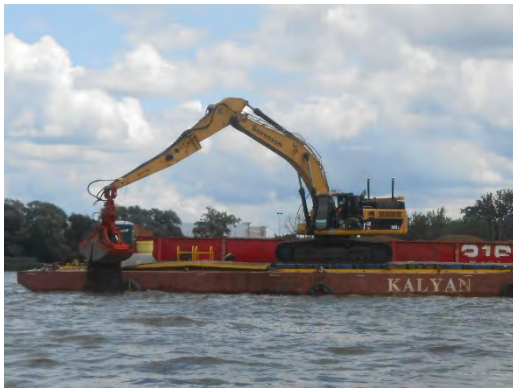
345D Excavator

For mechanical capping using lake-based equipment, cap materials were loaded onto transport scows with a loading capacity up to 400 tons and pushed using support vessels to the location of mechanical capping operations. Several excavators mounted on modular barges were utilized to place cap material in the lake, including a 345D excavator with a 2.25-cy clamshell bucket from 2012 through August 15, 2013, a Sennebogen 850 material handler with a 3-cy clam shell bucket after August 15, 2013, and a PC800LC excavator with a 3-cy clamshell bucket after August 1, 2014. Beginning on May 18, 2015, a telestacker unit was placed in service; the telestacker was a conveyor-based system used to place cap

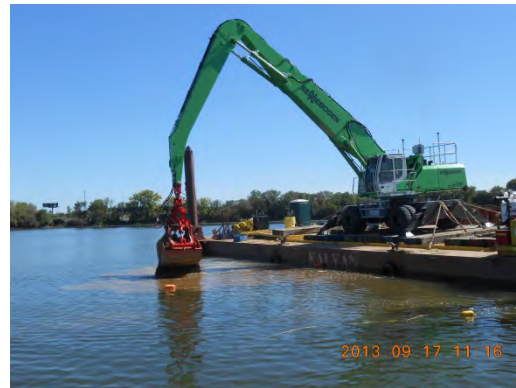
Sennebogen 850 Material Handler

materials in both nearshore and outboard areas. On the telestacker barge, a Sennebogen 850 material handler placed material into a feed hopper, which fed the cap material onto a dual conveyor belt that placed the material in the lake. The conveyor belt could be extended up to 120 feet from the modular barge upon which it was positioned. The feed hopper and conveyor belts used RTK-GPS technology and customized Hypack code to feed the conveyor belt with a specific volume of material based on target cap thickness, and place that volume of material at a precise location in the lake as identified using RTK-GPS.

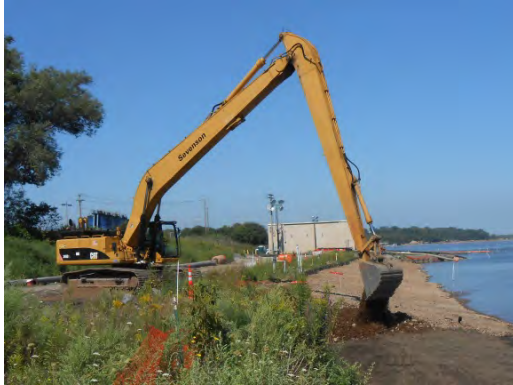
Capping from Shore – 345D Excavator

Shore-based mechanical capping was conducted using an excavator or telebelt positioned along the shoreline adjacent to the area being capped. Off-road dump trucks transported cap materials to the shore-based equipment, which subsequently placed the materials into the lake. Several shore-based pieces of equipment were used to place cap materials to the required thickness, including a PC220LC excavator, PC300LC excavator, CAT345D excavator, and telebelt. Most mechanical capping equipment was outfitted with RTK-GPS to guide material placement; for instances where the equipment operator did not have access to

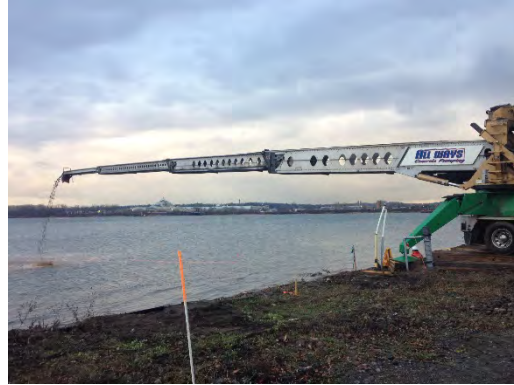
Telebelt Capping

RTK-GPS controls (e.g., telebelt operations), a QC surveyor accompanied the mechanical capping activity and provided guidance to the mechanical capping operator.

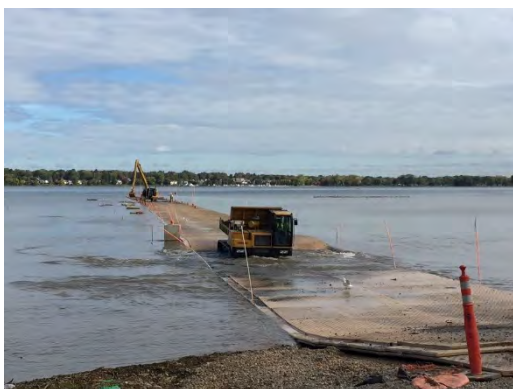
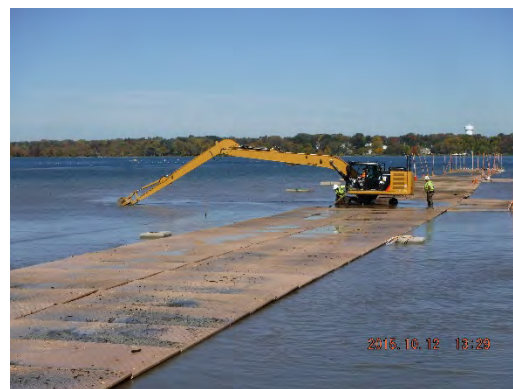
HDPE Mat Road and Truck Delivery of Topsoil Topsoil Placement Using HDPE Mat Road

HDPE mat roads were also utilized to place cap materials, primarily topsoil, in shallow-water areas where draft restrictions made the area difficult to access using either barge-based or shore-based capping operations. An excavator (CAT 320E or Komatsu 240LC) was positioned on the HDPE mat road, where it placed topsoil or other cap material into the lake. Low-ground pressure dump trucks (Morooka trucks) were used to transport material from onshore stockpiles to the excavator along the HDPE mat road. The HDPE mat road extended into the lake up to 1,200 feet from the shoreline.

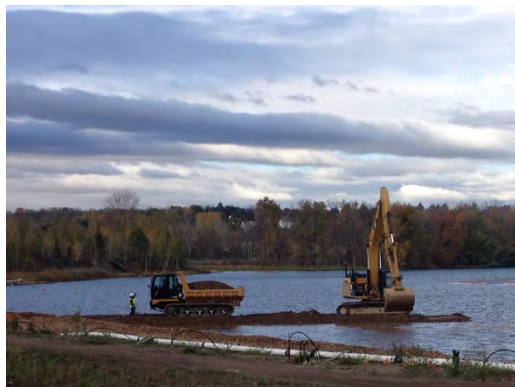
Delivery of Gravel for Shoreline Stabilization Shoreline Stabilization Placement

Morooka trucks were used to transport gravel to excavators that subsequently placed the gravel. Because portions of the shoreline stabilization area extended into the lake, the gravel was used to construct a temporary land bridge to access these portions of the placement area. The gravel from the land bridge was then side-cast into the placement area to complete the shoreline stabilization placement.

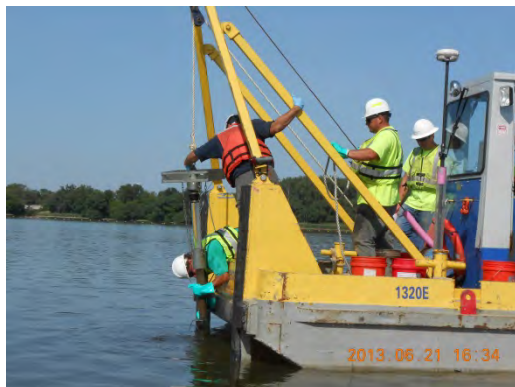
Gravity Core Retrieval

- Core samples (push cores, gravity cores, and vibracores)
- Catch pans (retrieval and measurement of the cap material retained by the catch pan)
- Survey data collection prior to and after the placement of a cap layer

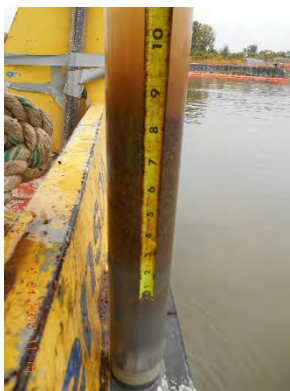
Gravity Core

Gravity cores were the primary method for measuring cap thickness for sand-sized cap layers (i.e., sand-siderite layer, sand-GAC layer, and sand-only habitat layers), up to a total cap thickness of approximately 30 to 36 inches. Vibracore samples were used to measure cap thickness in gravelly sand and fine gravel layers, and also if the cap thickness of sand layers was greater than 30 to 36 inches. Push cores were collected on a limited basis in shallow-water areas. Catch pans were used initially but were not used after November 2013 because field experience indicated that gravity coring and vibracoring were more effective measurement techniques (see Capping FCFs 007, 012, and 015 in Appendix 2B). Survey data collection was the primary method for measuring cap thickness for cap layers consisting of gravel-sized materials and shallow-water areas inaccessible by boat. Survey data to verify cap thickness was generally collected along tracklines spaced 15 feet apart in one direction (see Capping FCF 013 in Appendix 2B).

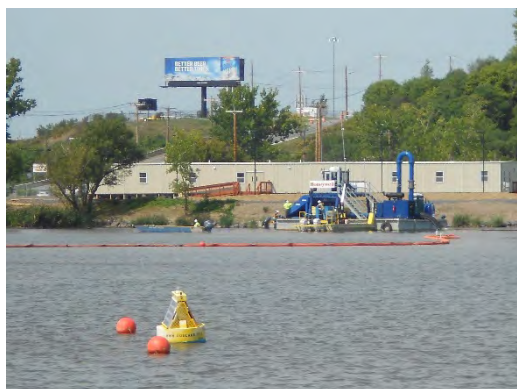
Turbidity Monitoring Buoy

Periodic turbidity measurements higher than alert levels were observed at performance monitoring locations positioned around hydraulic and mechanical capping operations. Measurements above the alert level were caused by either clean, imported sand from the hydraulic or mechanical capping operations, meteorological influences such as proximity of turbidity monitoring locations to tributary inflows, precipitation, and wind, or from erroneous measurements caused by either particulate growth on the sonde or a malfunction of the monitoring station equipment.

Three action level turbidity exceedances were recorded while monitoring capping activities. Anchor QEA, in coordination with NYSDEC, investigated the cause of these exceedances. None were determined to be the result of the remedial construction activities, as summarized below. The first action level exceedance occurred at RA-E compliance monitoring station OL-SW-CM-C020 during the night on July 2, 2013. An investigation of this exceedance found it to be the result of turbidity originating from Onondaga Creek following a rain event rather than from dredging or capping operations. The second action level exceedance occurred at RA-D and RA-E compliance monitoring station OL-SW-CM-041 on May 12, 2015. An investigation of this exceedance concluded that the elevated turbidity was a result of increased turbidity from Onondaga Creek following a precipitation event as well. Anchor QEA continued to monitor Onondaga Creek and the area of the lake impacted by the tributary inflow until the elevated turbidity subsided. The third action level exceedance occurred at RA-A compliance monitoring station OL-SW-CM-C047 from September 1 to September 2, 2015. An investigation of this exceedance concluded that the elevated

turbidity was from erroneous measurements caused by particulate growth on the turbidity probe.

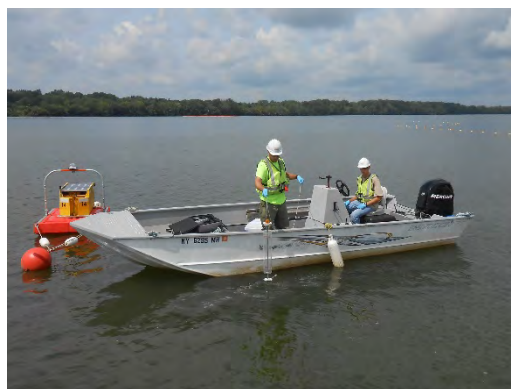
Discrete Water Column Sample Collection

Turbidity monitoring stations were classified as either performance monitoring stations or compliance monitoring stations. Performance monitoring stations were positioned approximately 200 feet from the edge of the turbidity control structure (i.e., silt curtain) during dredging, or approximately 200 feet from the work area demarcation system during capping activities. The intent of the performance monitoring stations was to monitor near-field turbidity near the construction area and provide an “early warning” of potential water quality impacts.

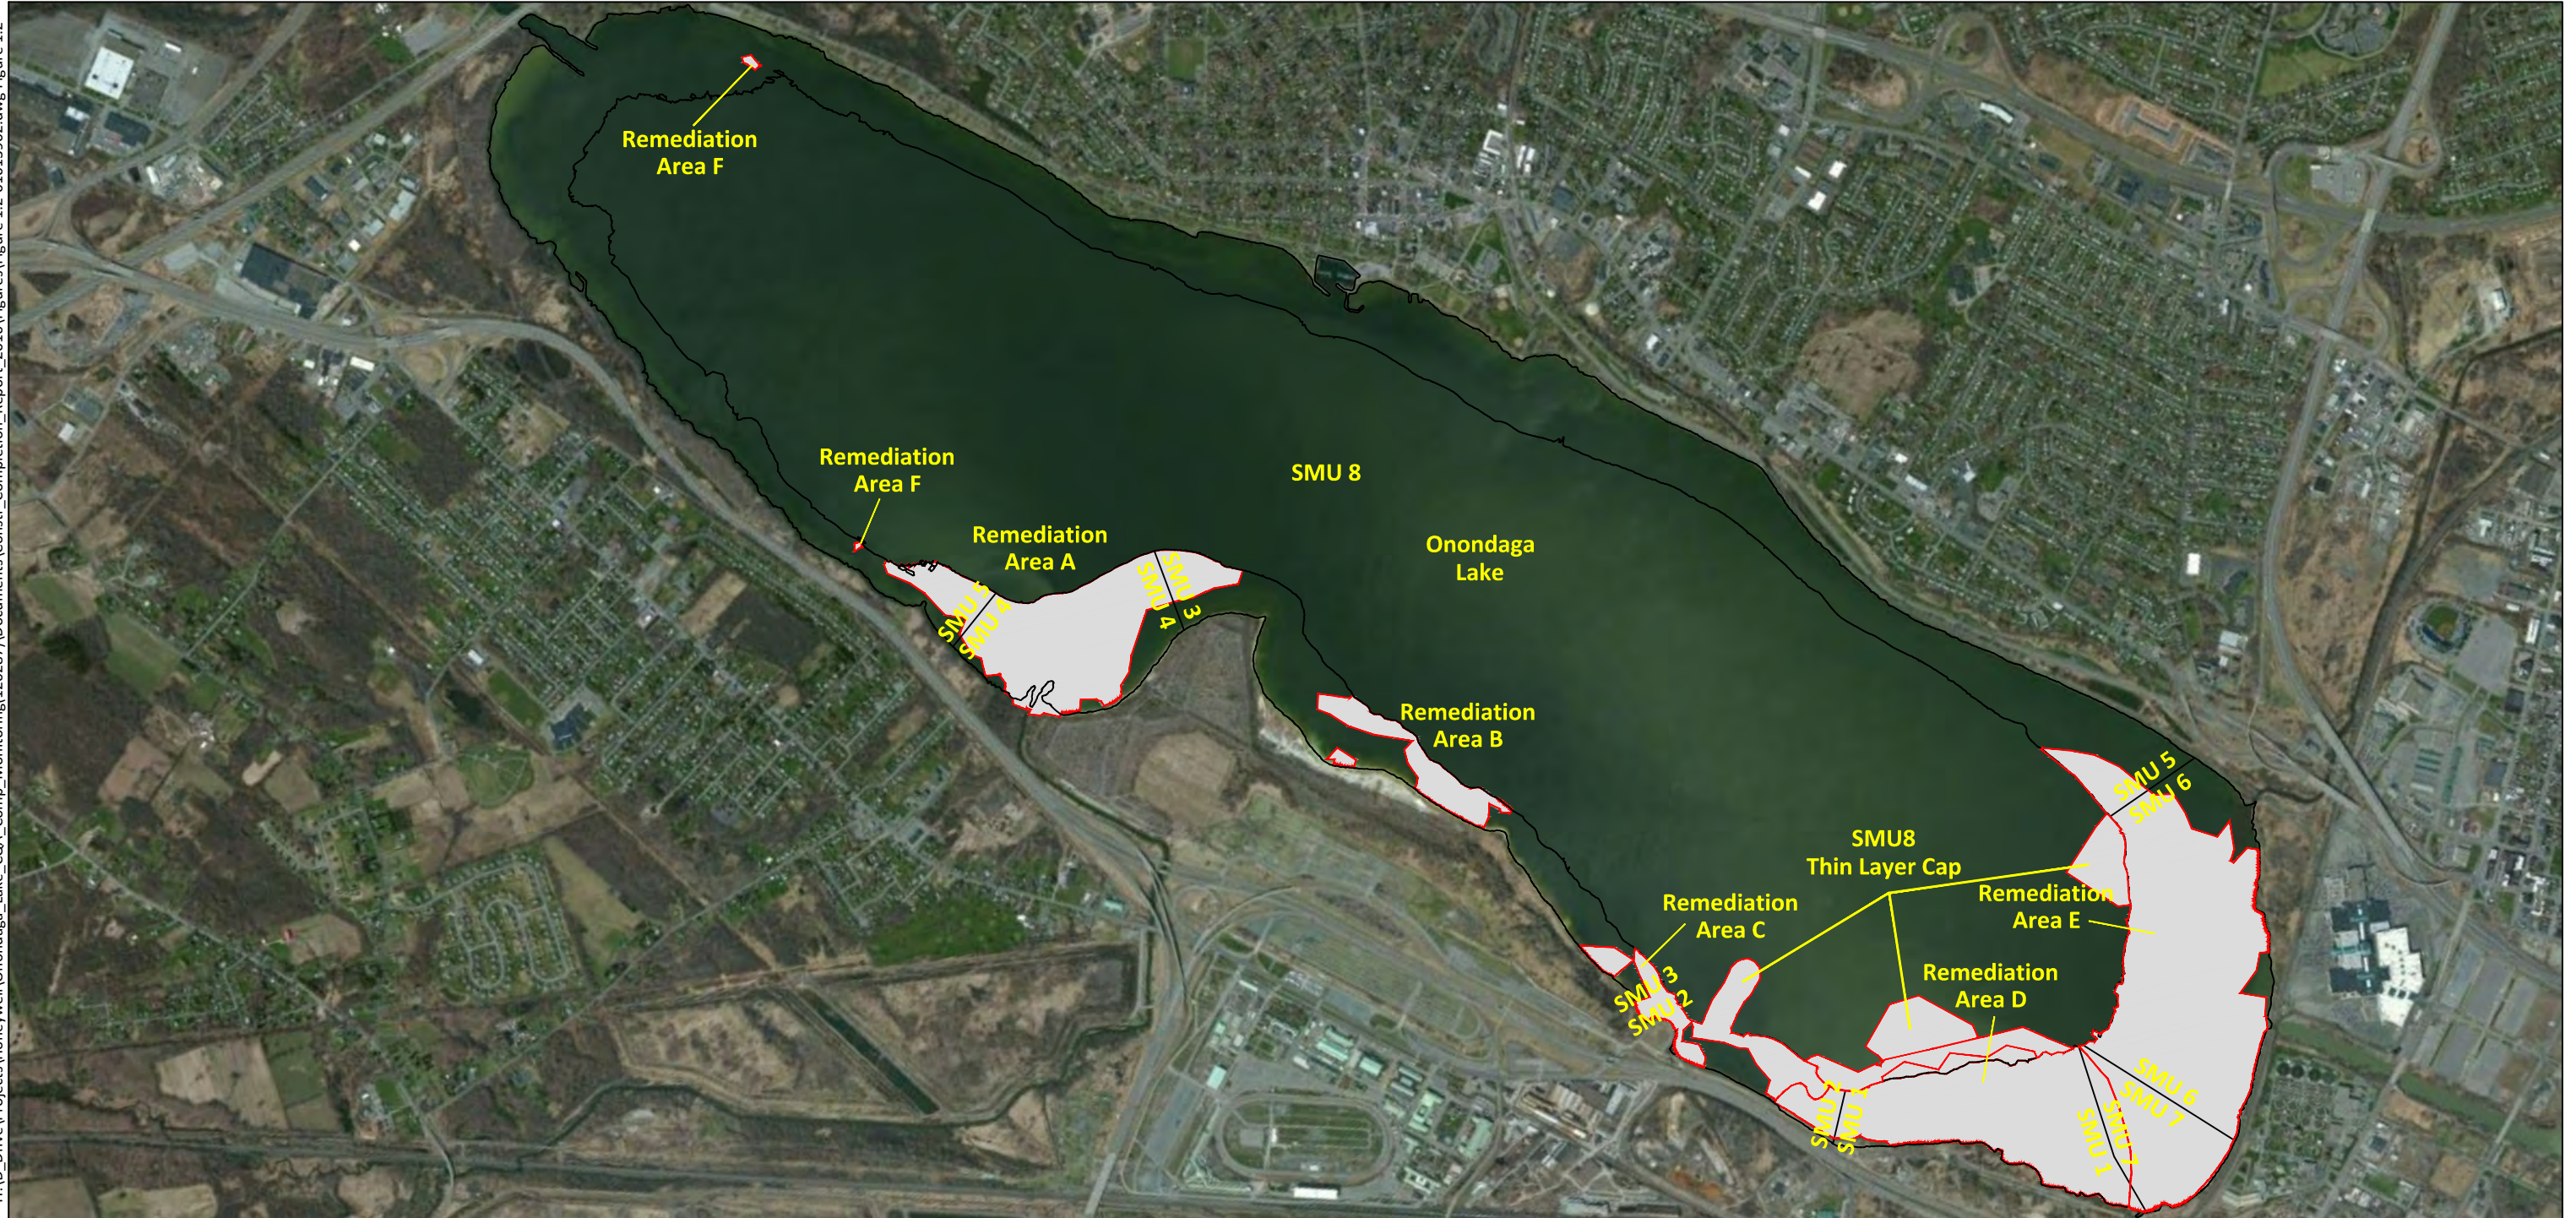
H:\D_Drive\Projects\Honeywell\Onondaga_Lake_COA_Comp_Monitoring(120287)\Documents\Constr_Completion_Report_2016\Figures\Figure 1.2-01013902.dwg Figure 1.2

To facilitate the design process, the littoral zone was re-divided into six distinct remediation areas (RAs), designated RA-A through RA-F (Figure 1-2), to replace SMUs 1 through 7. Thin-layer capping was also included in the remedy for select portions of the profundal zone (SMU 8). These remediation areas were established using data collected during the pre-design investigation, and collectively cover approximately 475 acres.
